AEM – November 17th 2014
David Caratelli
Nevis Laboratories @ Columbia University

Installation Progress

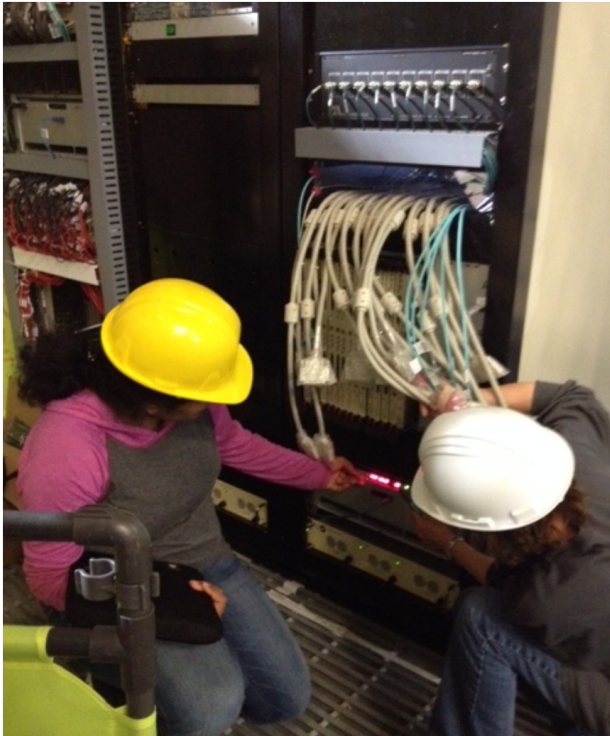
- Flanges 1-6 properly connected & strain-relieved
- All readout racks cabled up
- NIM logic for beam & external triggers in place

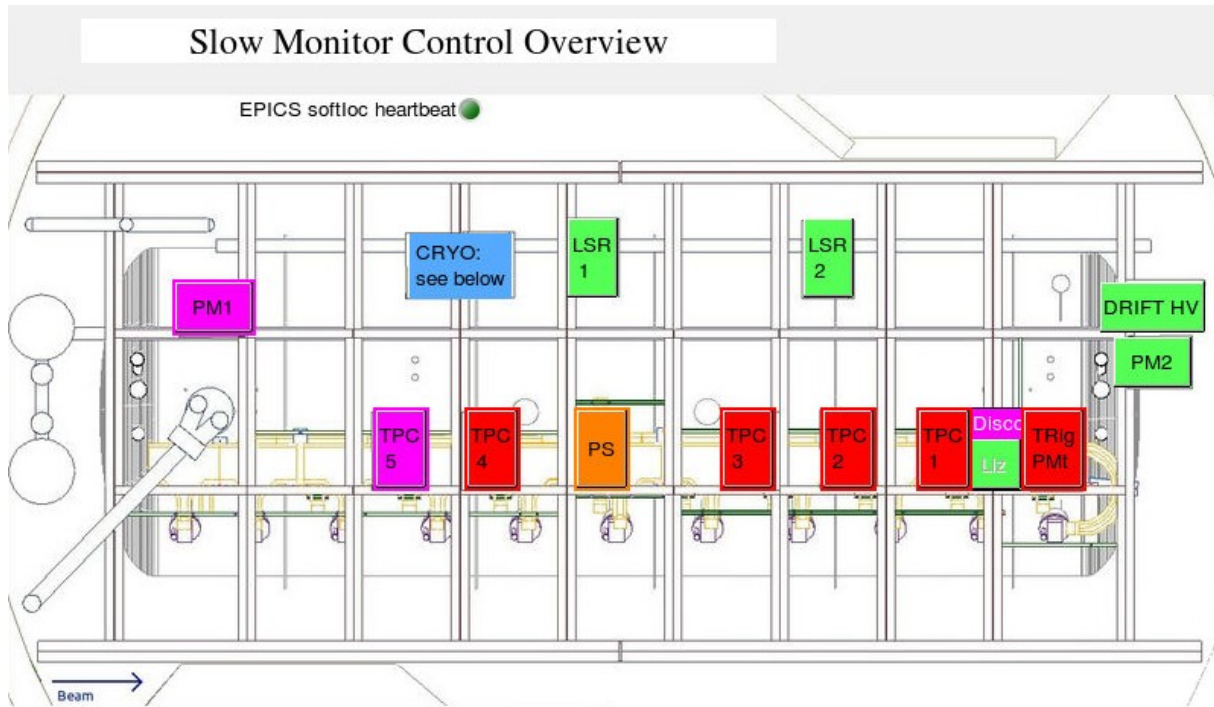
Low-level electronics status monitoring

GUI for remote rack monitoring/operation

GUI for crate power supply control.

GUI for Wiener Power Supply Operation

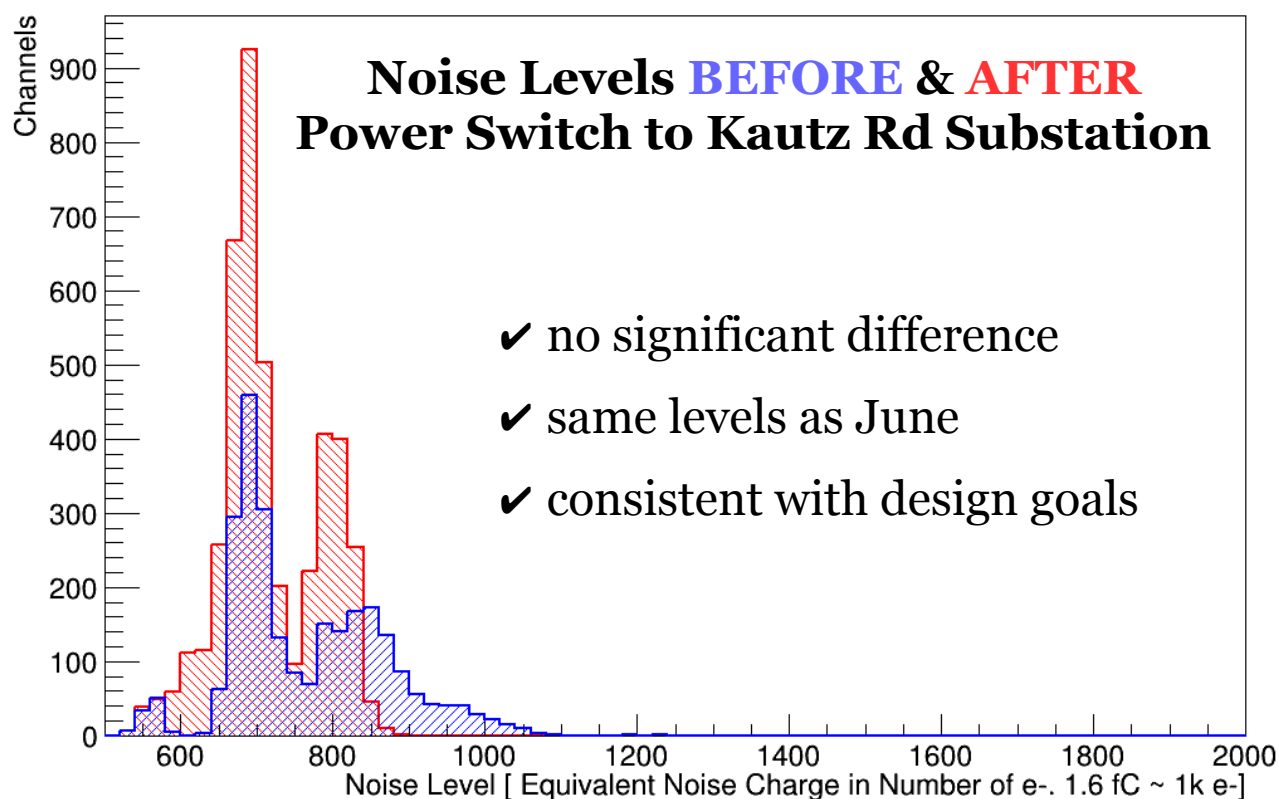
RMS Noise Levels Measured on TPC Wires

Took the opportunity to check effects on noise measurements while we tested readout.
Took data evening of Monday, Nov. 3rd and Saturday, Nov. 8th.

Demonstrated that the electronics on the platform function well and are stable over time.

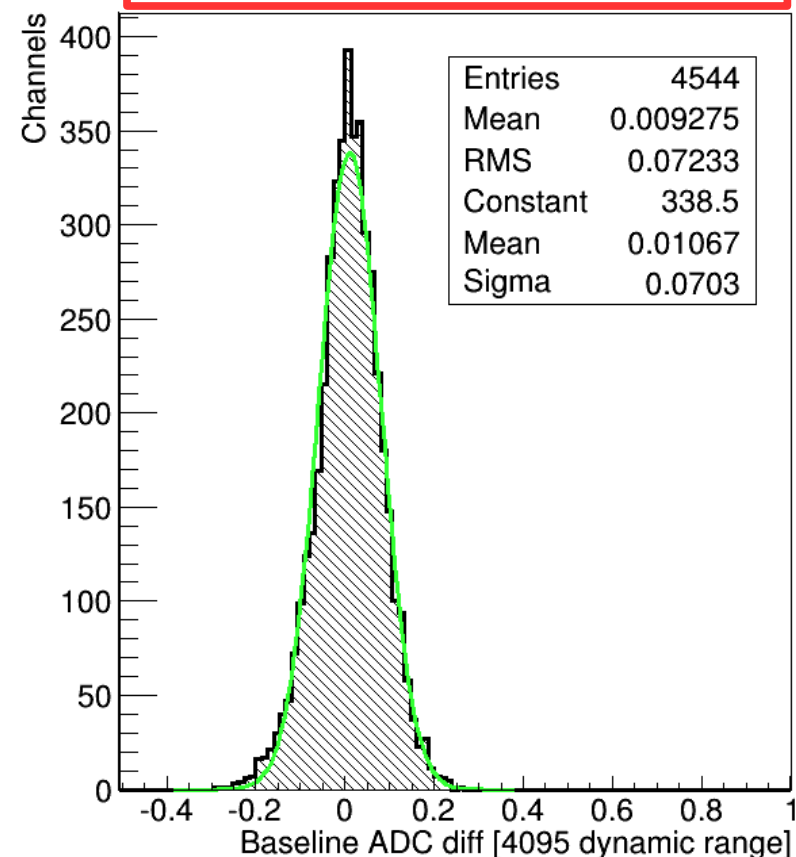
Pedestal diff. per chan. [Before-After Kautz Rd.]

First pORC right before power switch to Kautz Rd Substation.
